Name Of Dam: UPPER NORTH RIVER, NO. 77 (HEARTHSTONE LAKE)

PHASE I INSPECTION REPORT

NATIONAL DAM SAFETY PROGRAM

MICHAEL BAKER, JR., INC.

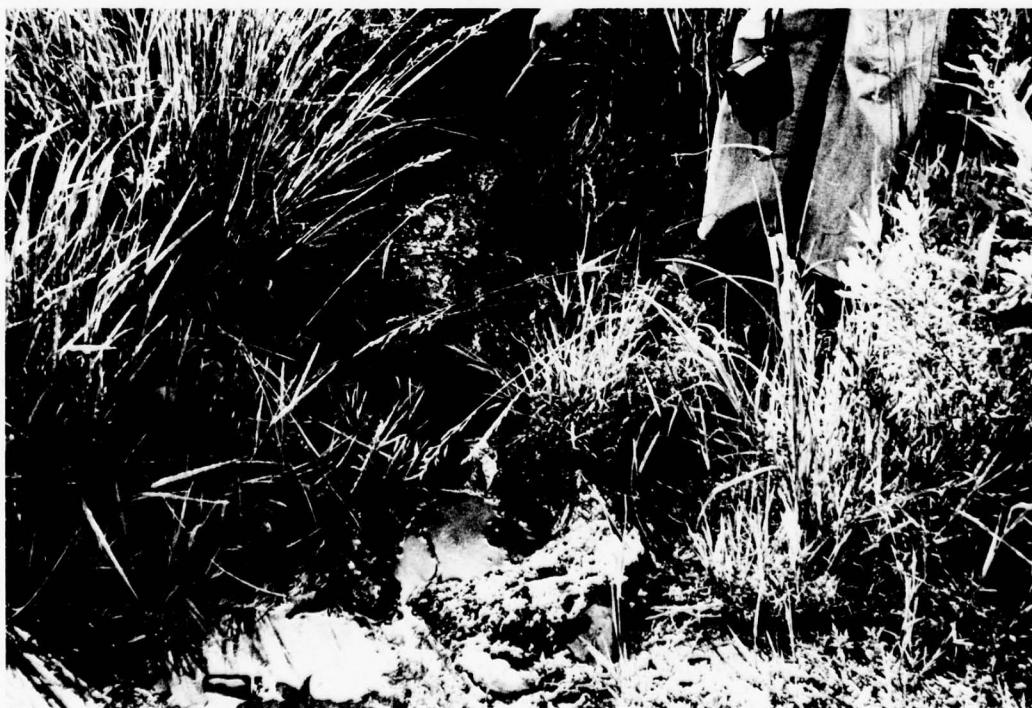
PHOTO 2

- 3.1.2 Dam: A small clear seep (see Photo 2) was noted during the visual inspection on the downstream face of the dam approximately 65 feet to the left of the outlet pipe along the upslope side of the bench on the embankment. The clear seep, approximately 25 feet higher than the outlet and one foot above the bench, is at an elevation of 1773 feet. The flow from the clear seep was not measurable and was estimated at less than one-half g.p.m. The reservoir elevation at the time of inspection was approximately 1778.5.

- 6.2.1 Visual Observations: No tension cracks or other evidence of movement such as sloughing of the embankment slopes, or movement at or beyond the toe was observed. One clear seep was observed on the downstream slope about one foot above the berm at an approximate elevation of 1773 feet. The flow from this clear seep was estimated to be less than 0.5 g.p.m. However, the reservoir level at the time of the inspection was only at elevation 1778.5.

- 7.1 Dam Assessment: The dam is designed to prevent overtopping under P.M.F. conditions. One clear seep was observed on the downstream face. The consequences of this clear seep depend on whether the source of water is the reservoir or infiltration on the embankment crest and slopes, and the effect of the clear seepage on embankment stability. There is a potential for piping if the clear seepage originates from the reservoir.

- 7.2.1 Clear Seep: Immediately, the owner should set up and maintain a regular observation schedule of inspecting the clear seep to determine its source, prevent erosion and prevent a worsening condition from going unobserved. If as a result of these periodic inspections, it is found that the flow is originating from the reservoir then an in-depth investigation including a test boring program and piezometers is recommended. An inverted filter may be needed to prevent piping if the source of the clear seep is determined to be the reservoir.

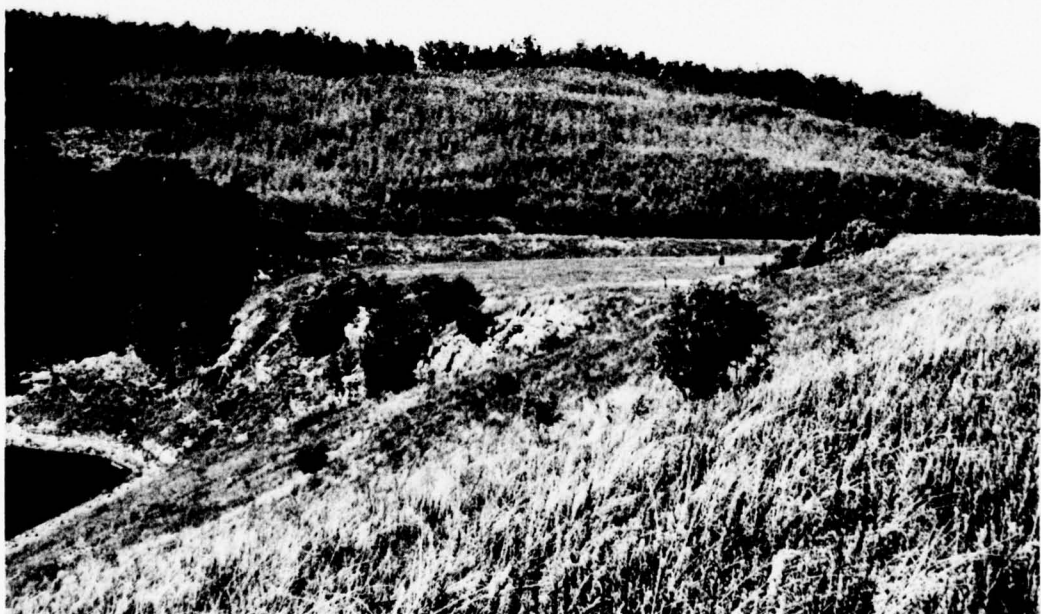
PHOTO 4

- The emergency spillway is well seeded and in good condition as shown in Photo 4.
- 3.1.4 Reservoir Area: No serious deficiencies were observed in the reservoir area (see Photo 5).
